# Manhole Inspection Summary

Manhole # S17YY\_013MH

Insp Date: **3/2/07 11:50 AM**

**Location** Address: **2440 DRUID PARK DR**

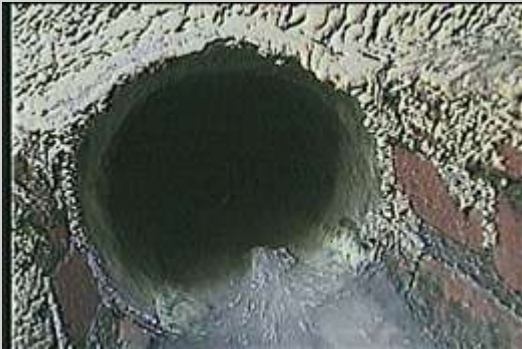
### 10 in. Circular Gravity Sewer Pipe Out @ 12 O'Clock

Pipe Material: **Unknown** ☒ Pipe Lined

Infiltration: **None** Pipe Seal Cond: **Sound**

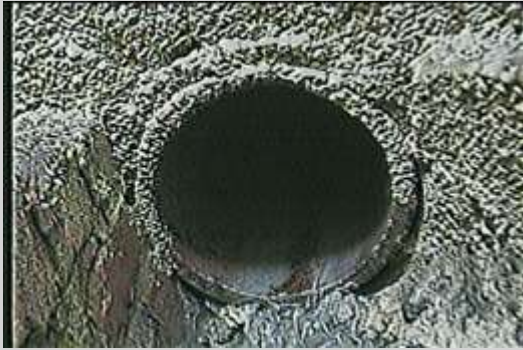
8 in. Circular Gravity Sewer

Pipe Material: **Clay** ☐ Pipe Lined

Infiltration: **None** Pipe Seal Cond: **Unknown**
